## TECHNICAL BULLETIN

## R2664P CENTRE SLEEVE SPIGOT

### **HAVE YOU KEPT THE CARTRIDGE FILTER CENTRE SLEEVE?**

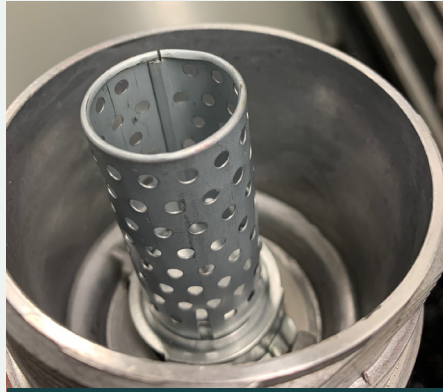
Image: No.01

- Missing the OEM perforated centre sleeve when installing a new filter cartridge
  - The centre Sleeve is also known as oil filter support tube, core, or spigot
- The sleeve attaches/locates in a groove at the bottom of the oil filter cap (Refer Image: No.01)
- The sleeve can be dislodged during removal of the existing filter – with it remaining captive in the old cartridge filter, and easily thrown away. (Refer Image: No.02)

- Workshops have been known to accidentally discard the perforated sleeve when discarding the old filter
- Be aware that cartridge filters often utilize a centre sleeve, a component of the oil cap housing.
- Always check the old filter before discarding, and ensure the centre sleeve has not dislodged and become stuck in the old filter.
- When replacing either R2620P, R2648P, R2651P or R2664P, ensure the perforated core/sleeve remains correctly located inside the filter cap. (Refer Images: No.06, 07 & 08)
- Perforated centre sleeves are not available as a separate part. A complete, new replacement filter housing must be purchased from the OEM

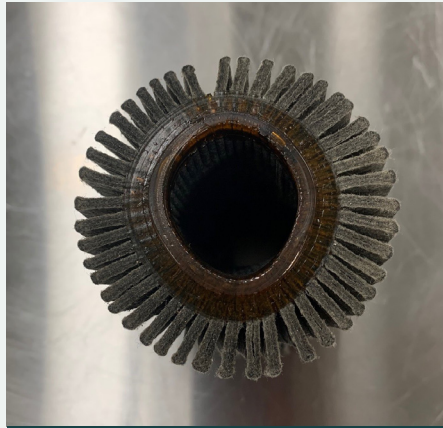
Image: No.03

- Failure to re-install the OEM perforated centre sleeve commonly results in twisting of the new cartridge element, potentially crushing the filter during operation. (Refer Images: No.03 & No.04)
- Distorting the filter adversely effects the flow properties of the filter.
- If the filter is to collapse, engine oil could flow unfiltered into the engine. (Refer Image: No.05)
- Allowing unfiltered oil to circulate through an engine can cause significant engine damage and /or possible failure.
