TECHNICAL BULLETIN

R2620P CENTRE SLEEVE SPIGOT

HAVE YOU KEPT THE CARTRIDGE FILTER CENTRE SLEEVE?

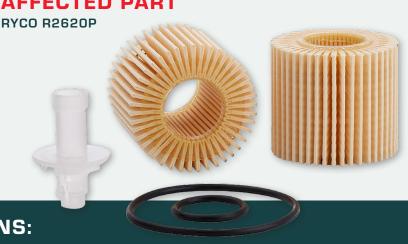
AFFECTED PART

Cartridge-style oil filter elements commonly fitted to a number of Toyota and Lexus vehicles where the OEM centre sleeve is incorporated into the oil filter cap, but can dislodge during routine service, and accidentally be thrown away.

- Missing the OEM perforated centre sleeve when installing a new filter cartridge
 - The centre Sleeve is also known as oil filter support tube, core, or spigot
- The sleeve attaches/locates in a groove at the bottom of the oil filter cap (Refer Image: No.01)
- The sleeve can be dislodged during removal of the existing filter - with it remaining captive in the old cartridge filter, and easily thrown away. (Refer Image: No.02)

- Workshops have been known to accidentally discard the perforated sleeve when discarding the old filter
- Be aware that cartridge filters often utilize a centre sleeve, a component of the oil cap housing.
- Always check the old filter before discarding, and ensure the centre sleeve has not dislodged and become stuck in the old filter.
- When replacing either R2620P, R2648P, R2651P or R2664P, ensure the perforated core/ sleeve remains correctly located inside the filter cap. (Refer Images: No.06, 07 & 08)
- Perforated centre sleeves are not available as a separate part. A complete, new replacement filter housing must be purchased from the OEM
